Intervention dans le cadre d'un accident de fonte de source orpheline dans une industrie sidérurgique

X. Delcorps, P. Froment, M. Bricoult, J Van Cauteran.

Point de depart

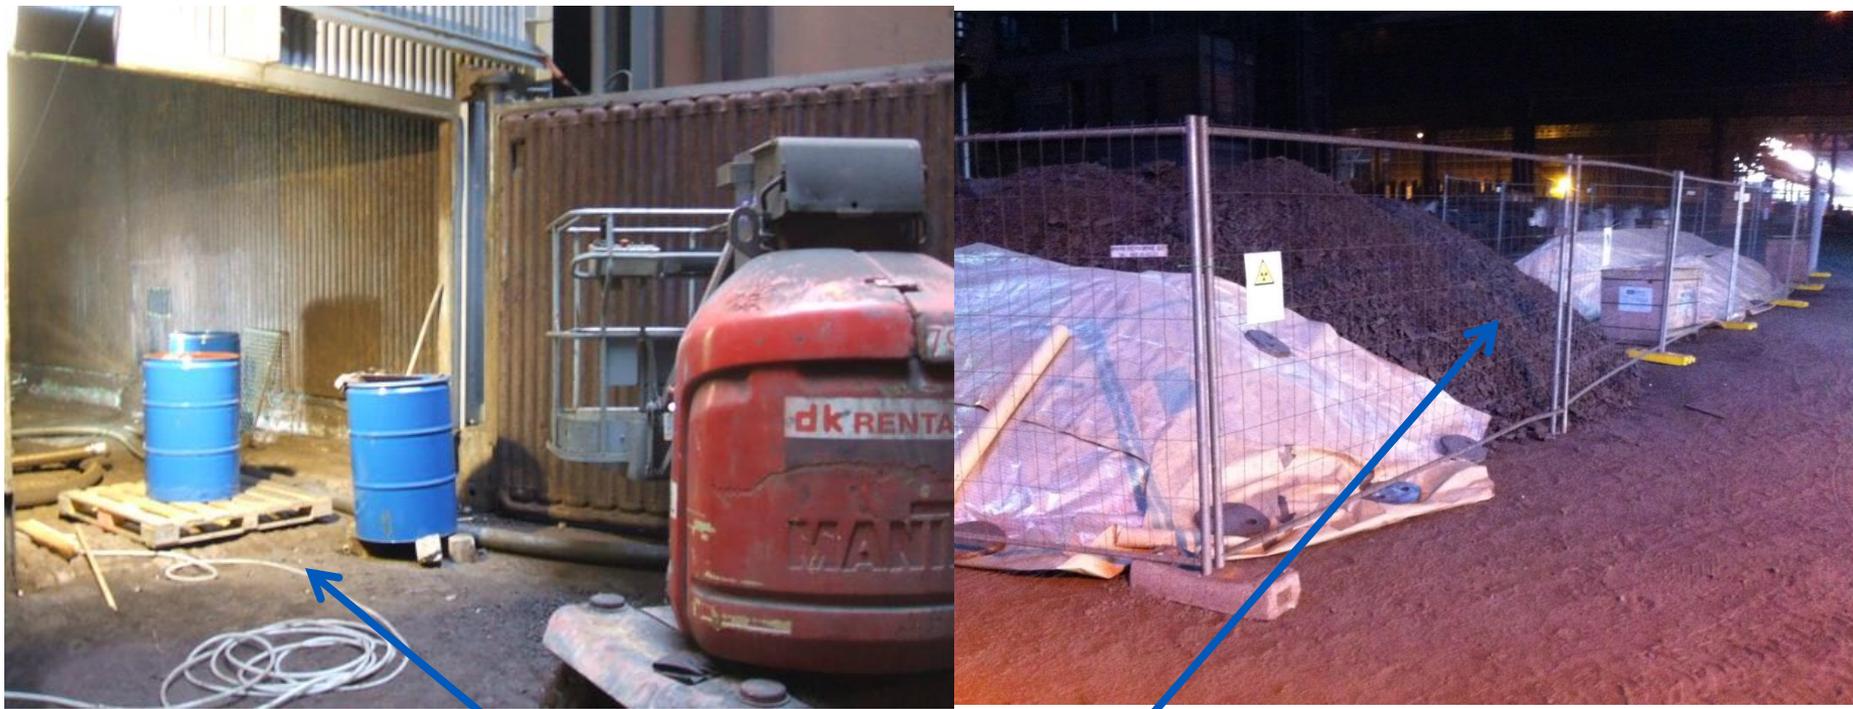
Chambre de Combustion

Contamination fixée

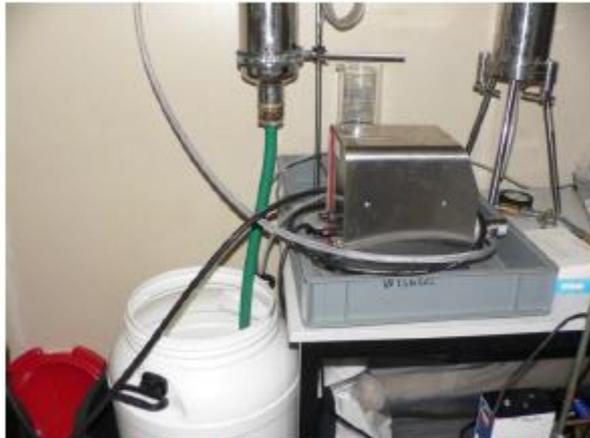
Fig. 6.7. 10 µm-Filtration of Washing Water.

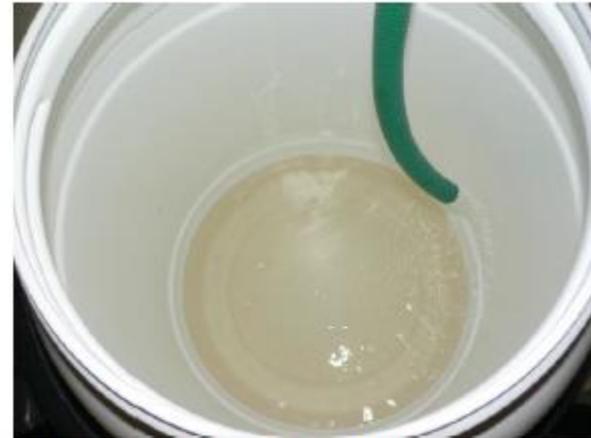
Fig. 6.8. Filtered Washing Water.

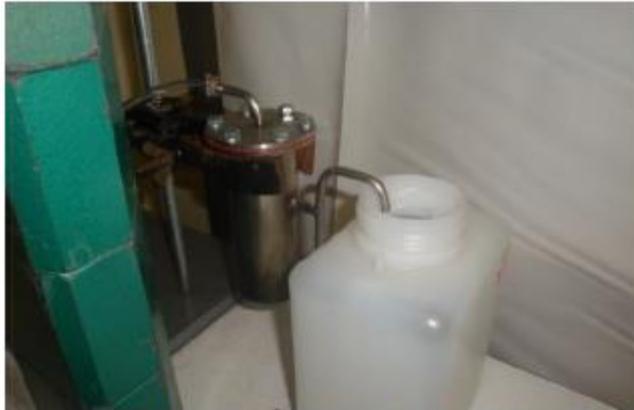
Fig. 6.9. Adsorption column and collecting vessel.

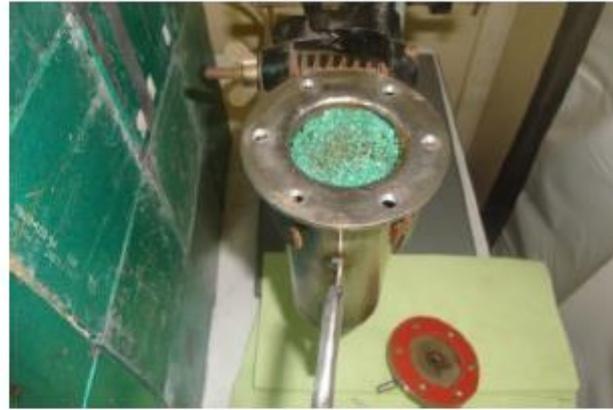
Fig. 6.10. Open column with NHCYF.

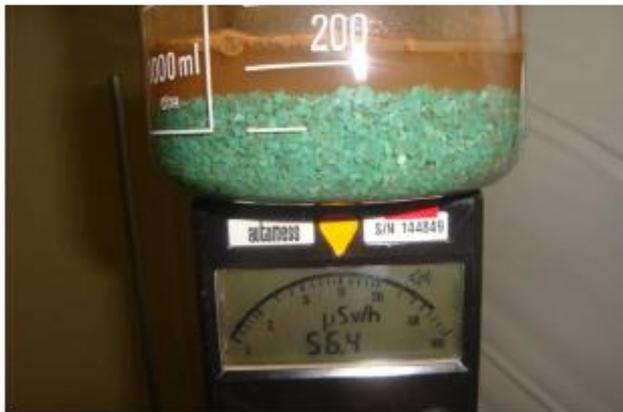
Fig 6.11: Used NHCYF from the column containing ^{137}Cs

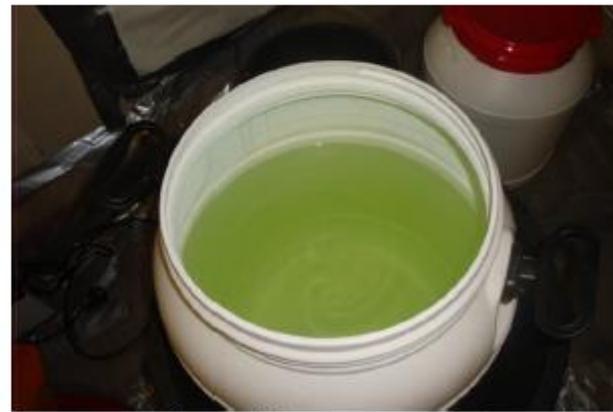
Fig 6.12: Collected decontaminated washing water
