Intervention dans le cadre d'un accident de fonte de source orpheline dans une industrie sidérurgique

X. Delcorps, P. Froment, M. Bricoult, J Van Cauteran.

Point de depart

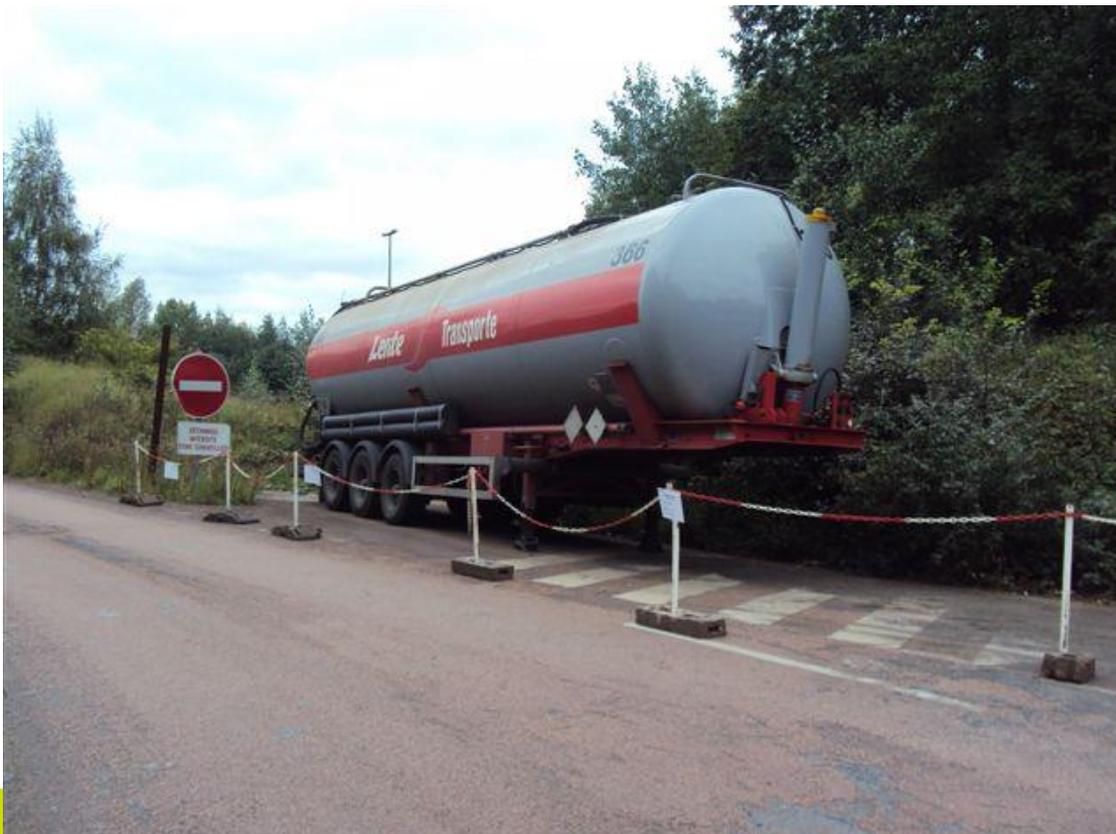
12 septembre 2011 : Détection de Radioactivité

RECYTECH - Fouquières les Lens (F)

30 $\mu\text{Sv/h}$

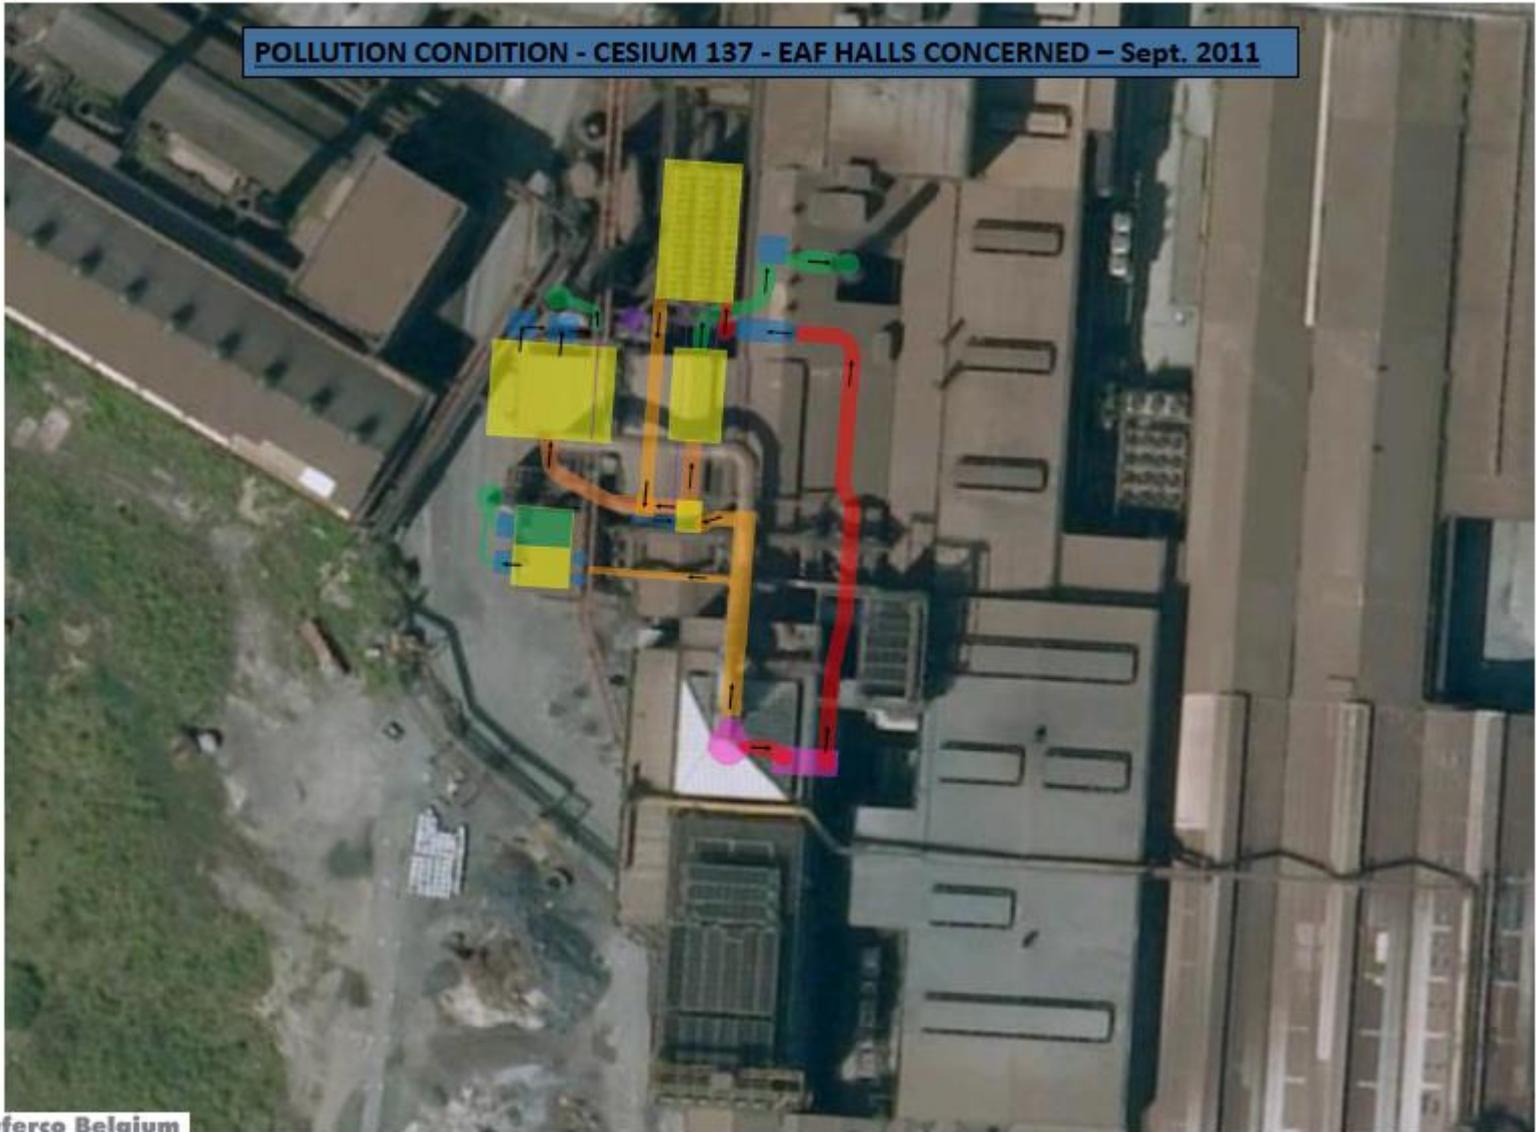
POLLUTION CONDITION - CESIUM 137 - EAF HALLS CONCERNED – Sept. 2011

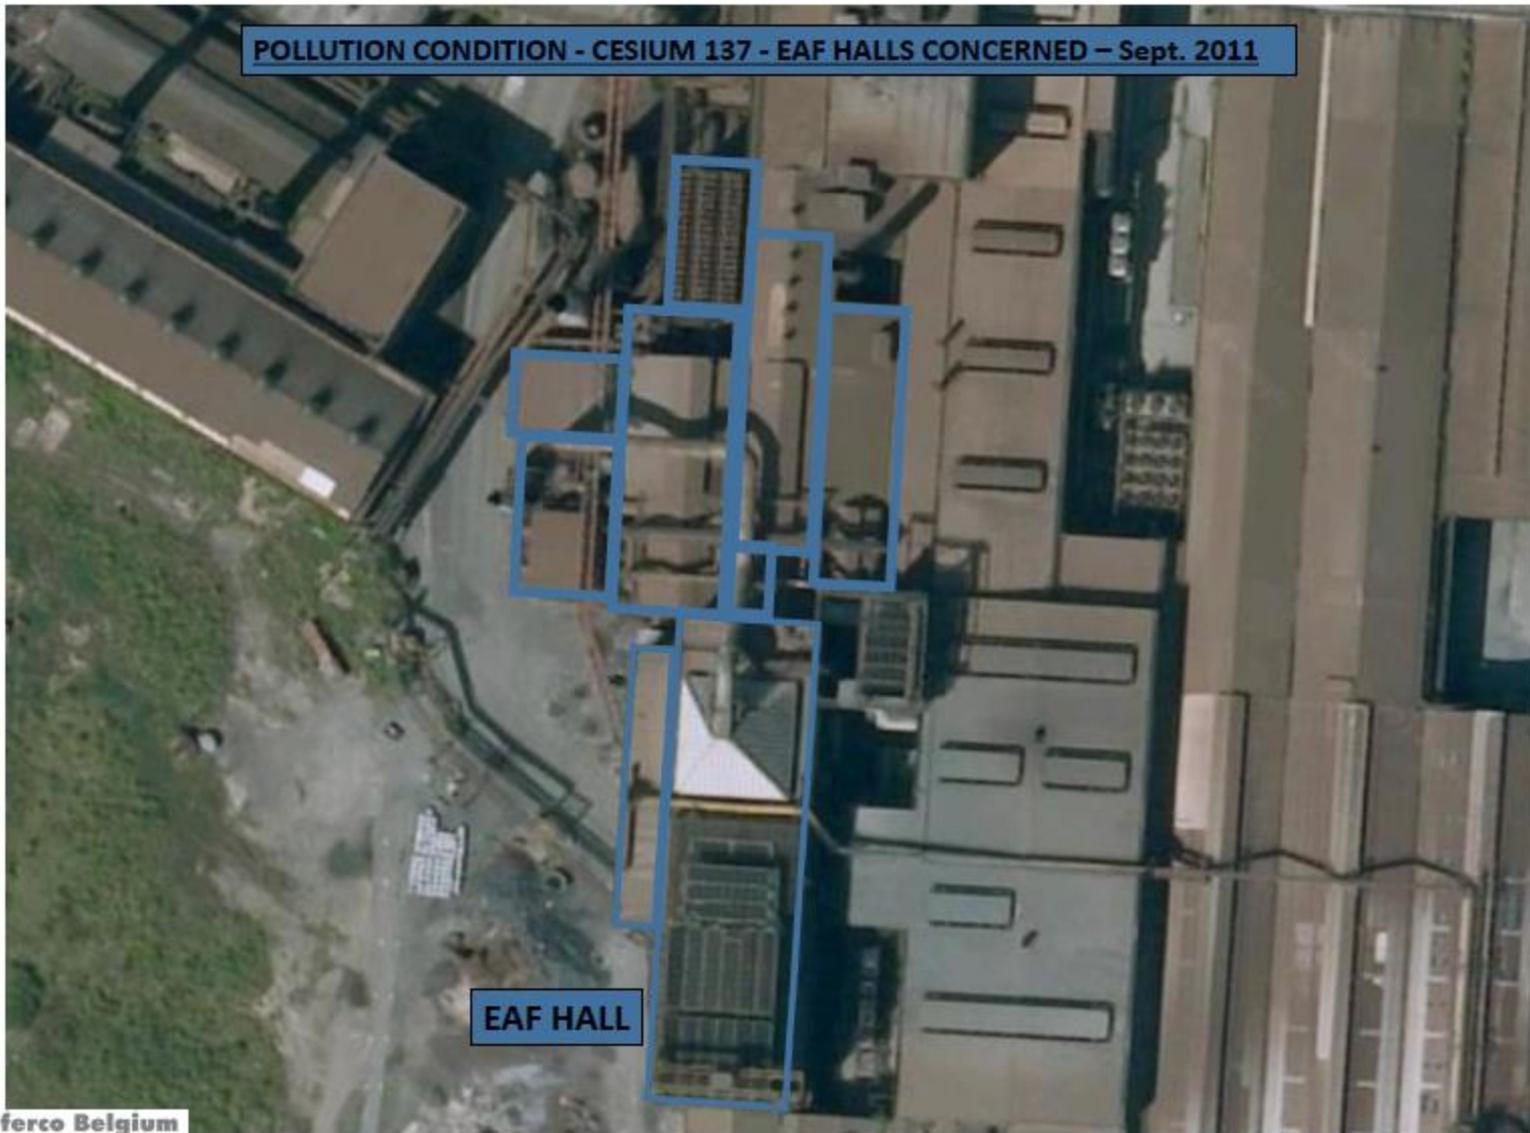
POLLUTION CONDITION - CESIUM 137 - EAF HALLS CONCERNED – Sept. 2011

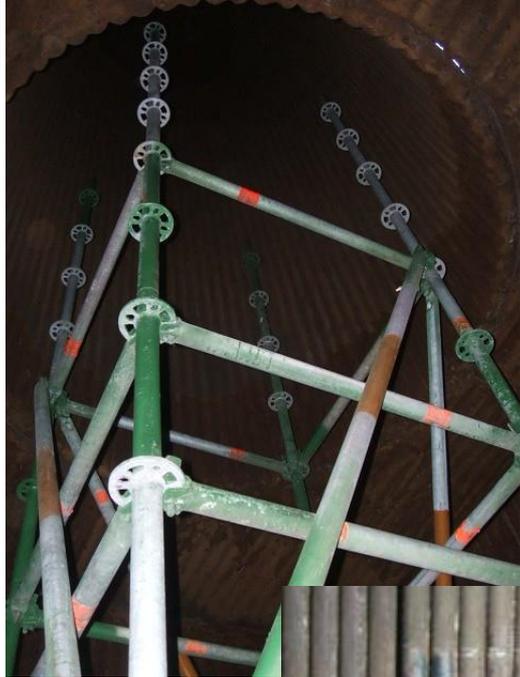
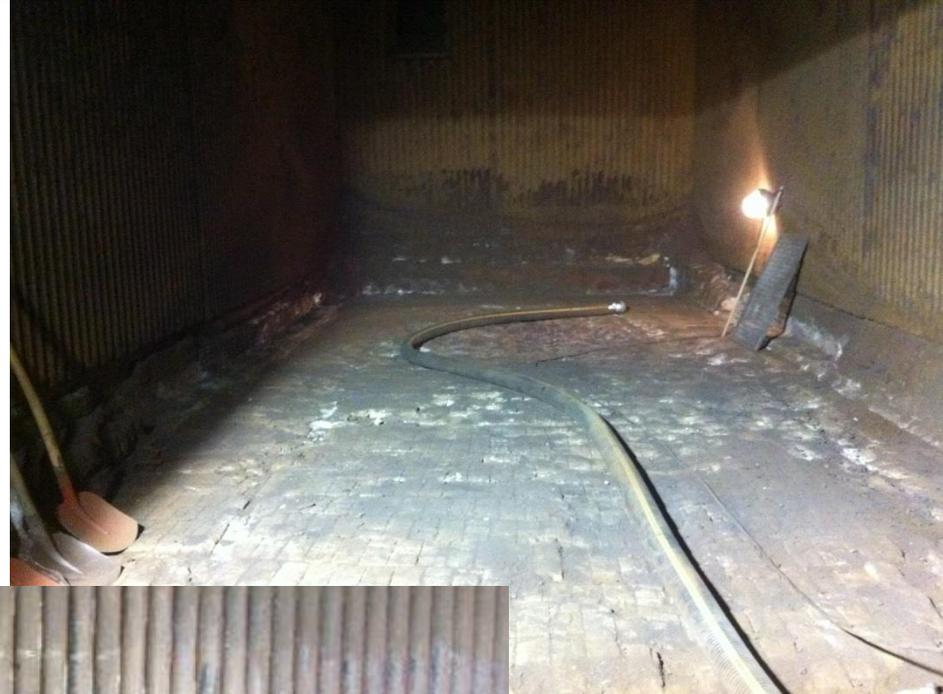
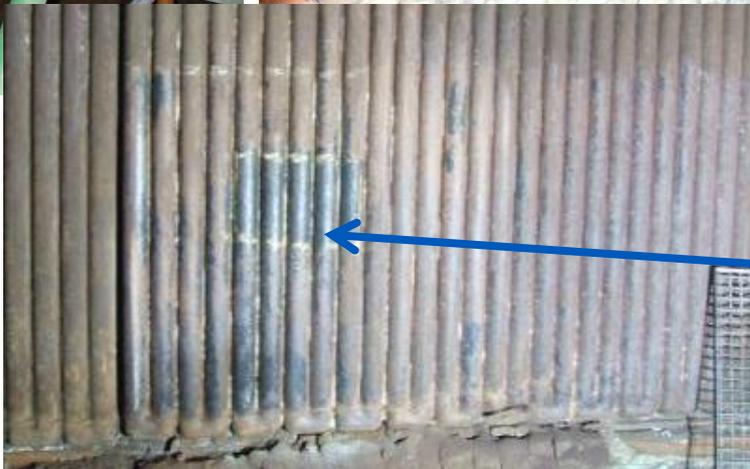
Chambre de Combustion

Contamination fixée

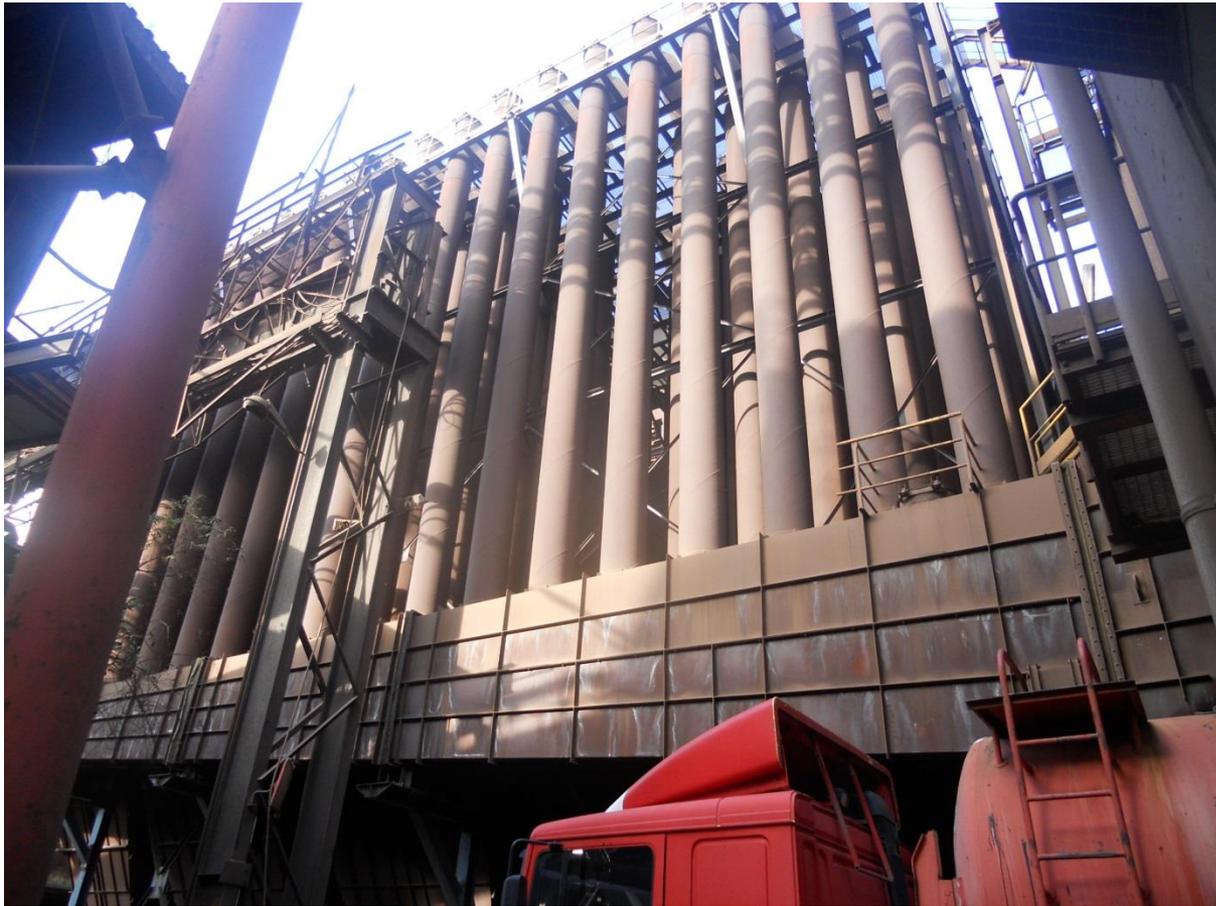
Airpin Cooler

Gaine refroidie	53.7 Bq/g (Cs 137)
AirPinCooler	16.4
Danieli	67.7
Demag	34.6

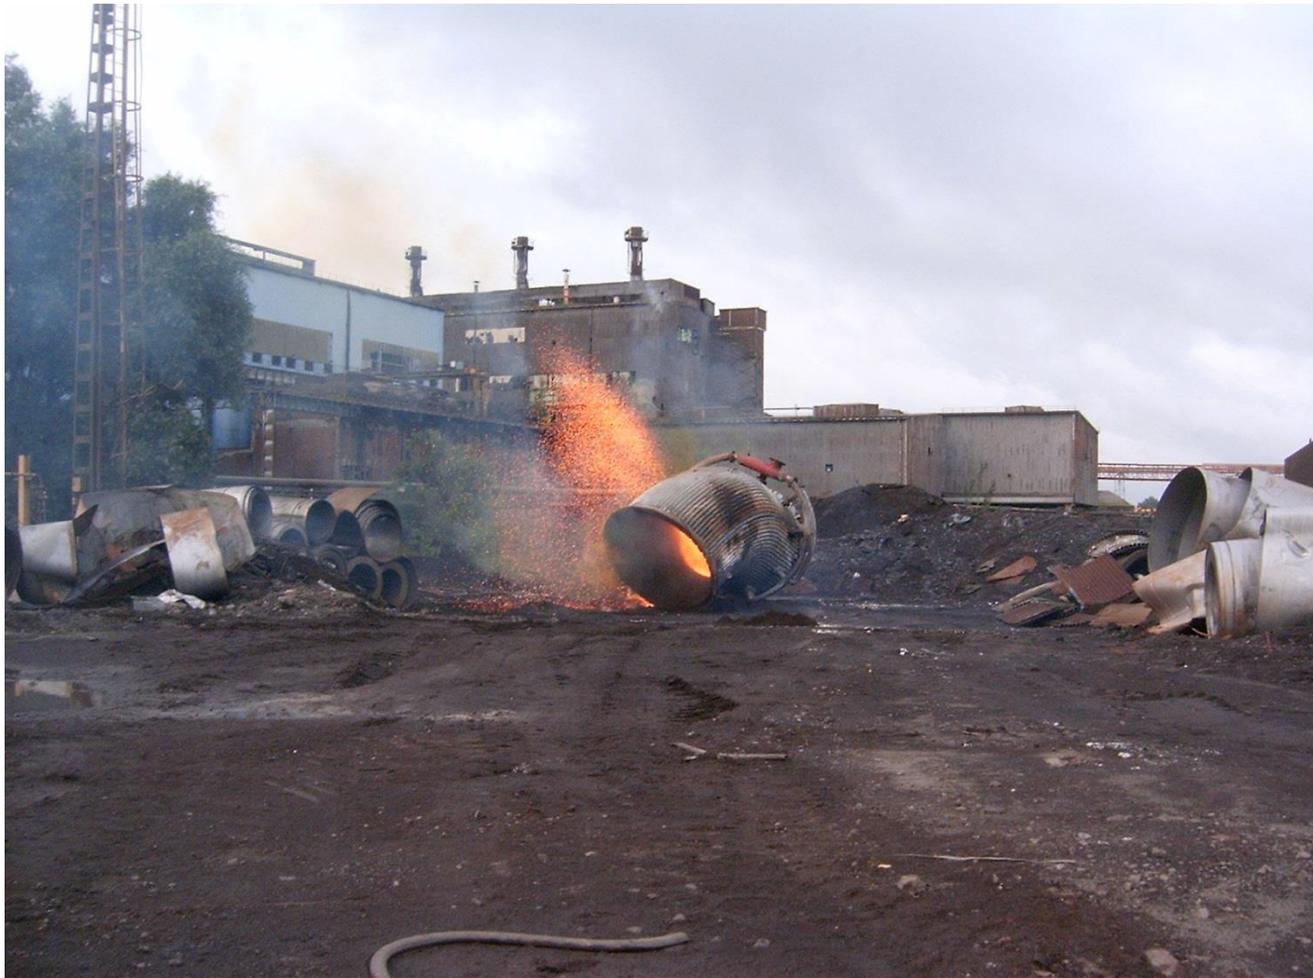
Suivi des équipements contaminés

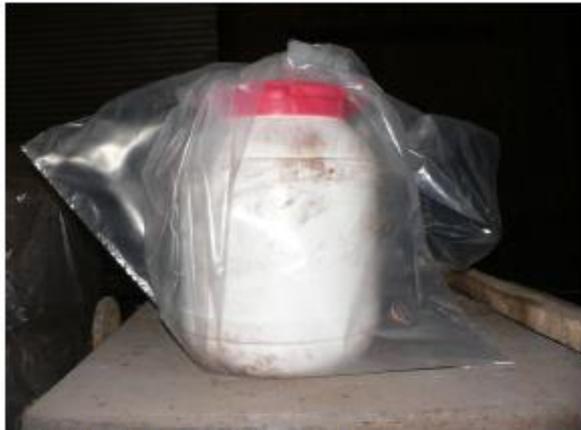
Fig. 6.1. Filter dust barrel.

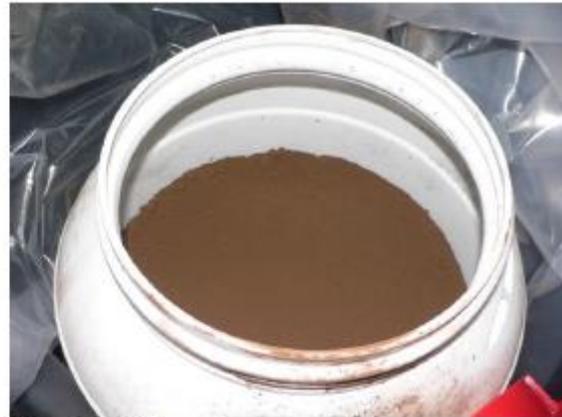
Fig. 6.2. Filter dust.

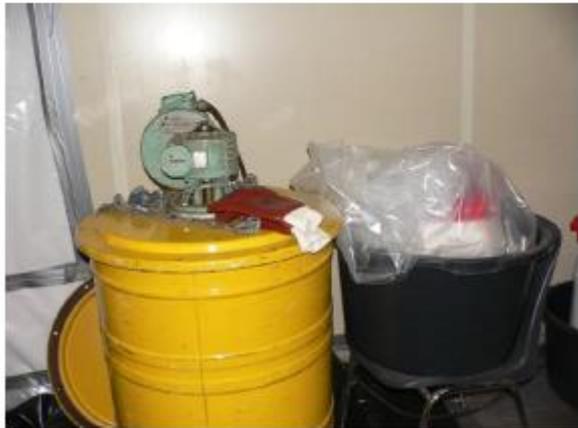
Fig. 6.3. Yellow dust barrel with stirring device.

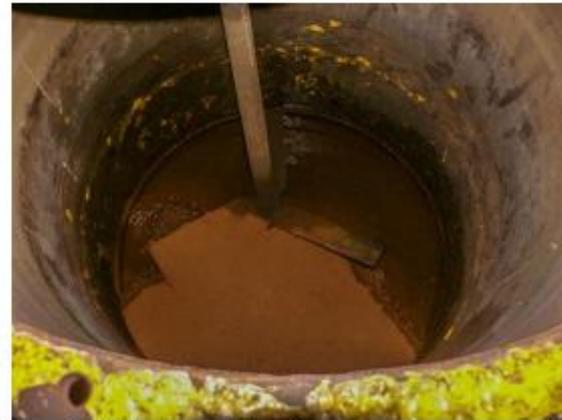
Fig. 6.4. Preparation for suspension and dissolution.

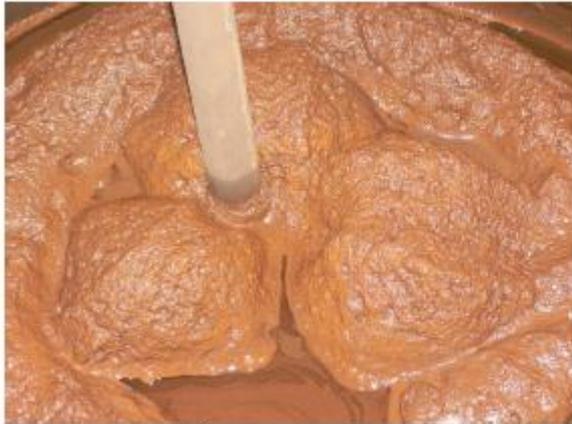
Fig. 6.5. Dust during stirring.

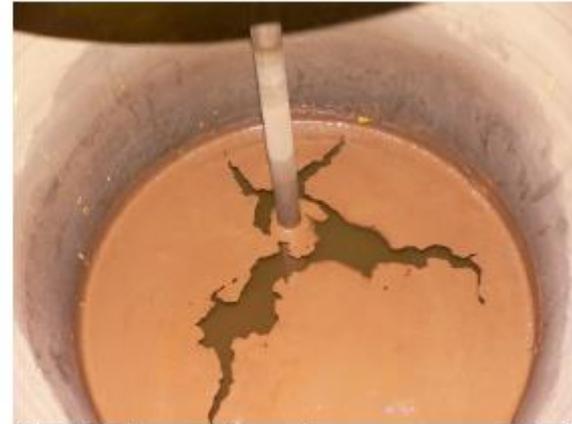
Fig. 6.6. Dust skin and supernatant solution.
